TGHP

MARKINGS

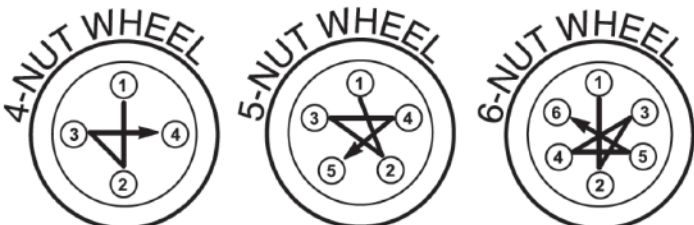
Tightening wheel nuts

Tighten wheel nuts in a criss-cross sequence shown in the diagram by hand and check with a torque wrench. Failure to tighten nuts in a criss-cross sequence can cause uneven clamping of the rotor.
